99-7888 DW-7888 INSTALLATION INSTRUCTIONS

APPLICATIONS

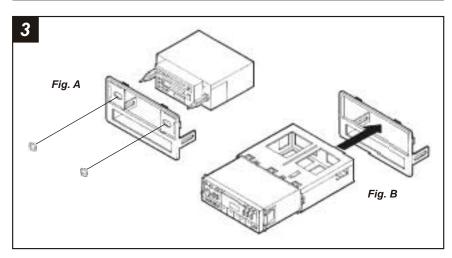
2-SHAFT HEAD UNITS: Slide the aftermarket head unit into the kit and secure with shaft nuts. (see Fig. A)

<u>DIN HEAD UNITS:</u> Cut and remove the shaft supports from the *Radio Housing*. Slide the DIN cage into the kit and secure by bending the metal locking tabs down. Slide the aftermarket head unit into the cage until secure. (see Fig. B)

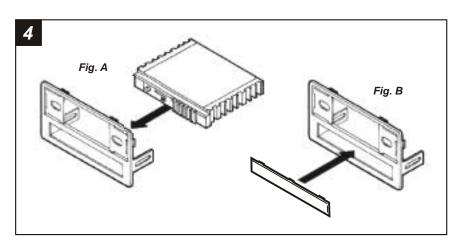
IF AN EQUALIZER WILL BE INCLUDED: Slide the aftermarket equalizer into the back of the **Radio Housing.** Using the hardware included with the equalizer, mount the unit to the kit. (see Fig. A)

IF AN EQUALIZER WILL NOT BE INCLUDED: Snap the **Equalizer Dummy Plate** into the **Radio Housing.** (see Fig. B)
