99-7898 INSTALLATION INSTRUCTIONS

APPLICATIONS

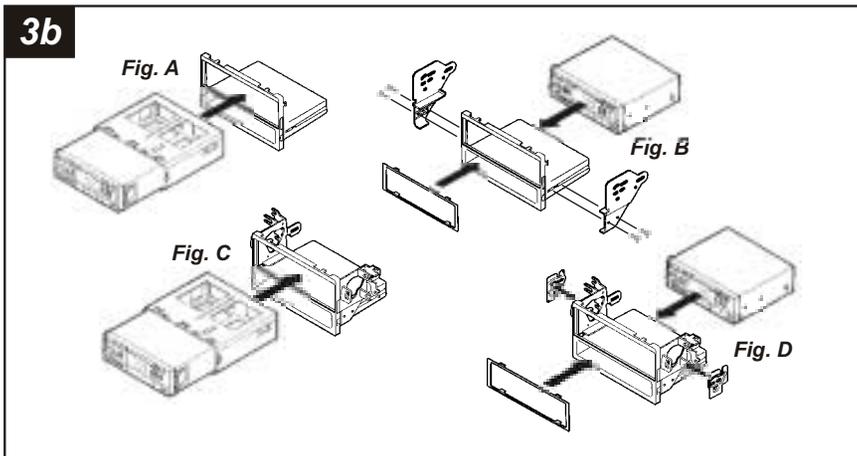
3b

ACCORD 1990-97, CIVIC 1999-00, CL 1997-99, CRV 1997-02, INTEGRA 1990-01, LEGEND 1990-96, OASIS 1995-98, ODYSSEY 1995-98, PRELUDE 1989-01, RSX 2002, TL 1996-98, VIGOR 1992-94: **DIN HEAD UNITS:** Slide the DIN cage into the kit and secure by bending the metal locking tabs down. Slide the aftermarket head unit into the cage until secure (see Fig. A). **ISO HEAD UNITS:** Snap the **ISO Trimming** into the **Radio Housing**. Mount the **ISO Brackets** to the Radio Housing with (4) #8 x 3/8" Phillips Screws supplied. Slide the aftermarket head unit into the Housing, align the holes in the unit with the holes in the Brackets and mount with the screws supplied with the unit (see Fig. B).

ACCORD 1998-02, ODYSSEY 1999-02: **DIN HEAD UNITS:** Slide the DIN cage into the kit and secure by bending the metal locking tabs down. Slide the aftermarket head unit into the cage until secure (see Fig. C). **ISO HEAD UNITS:** Attach the **ISO Spacers** onto the sides of the **Mounting Brackets** and snap the **ISO Trimming** into the **Radio Housing**. Slide the aftermarket head unit into the Housing, align the holes in the unit with the holes in the ISO Spacers and mount with the screws supplied with the unit (see Fig. D).

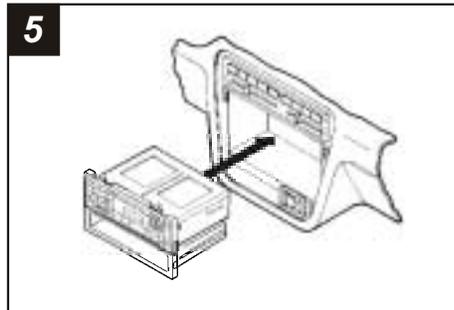
Locate the factory wiring harness in the dash. Metra recommends using the proper mating adaptor and making connections as shown. (Isolate and individually tape off the ends of any unused wires to prevent electrical short circuit).

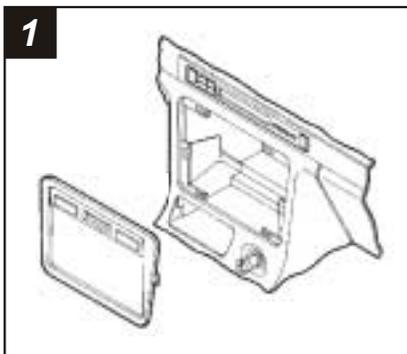
ACURA CL 1997-99

Disconnect the negative battery terminal to prevent an accidental short circuit. Unclip the radio trim bezel and disconnect the clock and climate control wiring. Remove (2) 8mm hex-head screws securing the factory head unit and disconnect the wiring.

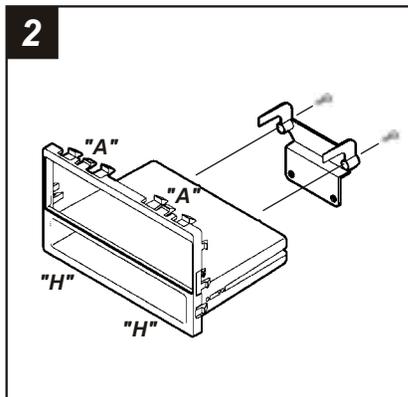
Cut and remove the all mounting clips on the **Radio Housing** EXCEPT clips "A" and "H". (The clips can be identified by the stamped letter near each clip). Mount the **Rear Support Bracket #R1** to the back of the Radio Housing with (2) #8 x 3/8" Phillips Pan-head Screws supplied. Skip to step #3b on Page 11.

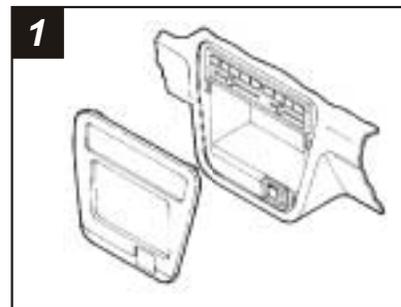
HONDA Prelude 1997-01

Disconnect the negative battery terminal to prevent an accidental short circuit. Using a panel removal tool, unclip the radio trim bezel and remove (some force may be required). Remove (4) Phillips screws securing the factory head unit/bracket housing assembly and disconnect the wiring. Remove (4) Phillips screws securing the factory head unit to the bracket housing and remove.

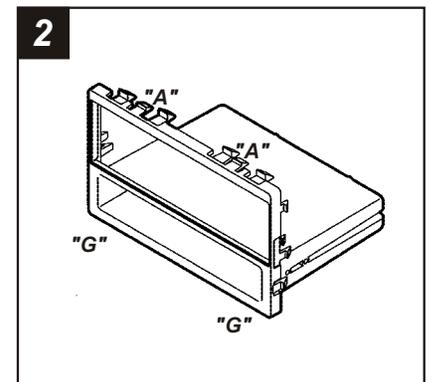
Cut and remove the all mounting clips on the **Radio Housing** EXCEPT clips "A" and "G". (The clips can be identified by the stamped letter near each clip). Skip to step #3b on Page 11.

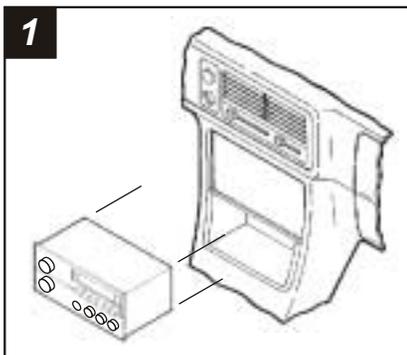
ACURA Integra 1990-93

Disconnect the negative battery terminal to prevent an accidental short circuit. Remove (3) screws from each side of the center console and remove the console. Remove (2) screws securing the factory head unit to the sub-dash support bracket. Slide the head unit/pocket assembly out and disconnect the wiring.

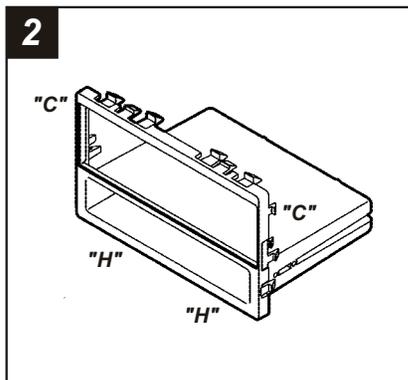
Cut and remove the all mounting clips on the **Radio Housing** EXCEPT clips "C" and "H". (The clips can be identified by the stamped letter near each clip). Skip to step #3b on Page 11.

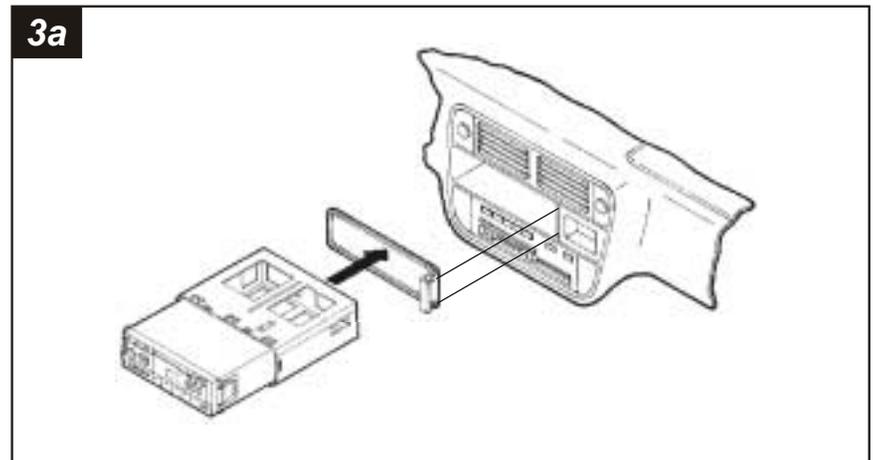
CIVIC 1996-98:

DIN HEAD UNITS: Disconnect the negative battery terminal to prevent an accidental short circuit. Position the **Faceplate** in the radio opening by inserting the locating pins on the Housing into the holes in the sub-dash. (NOTE: If a radio dummy plate was removed during the dash disassembly, cut and remove the locating pins on the Radio Housing). Slide the DIN cage into the kit and secure by bending the metal locking tabs down. Slide the aftermarket head unit into the cage until secure. (THIS CONCLUDES THE INSTALLATION).

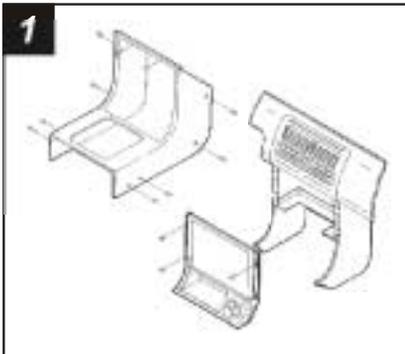
HONDA Prelude 1992-96

Disconnect the negative battery terminal to prevent an accidental short circuit. Remove (2) screws from the top of the console trim bezel. Slide the front seats back and remove (4) Phillips screws from each side of the bezel. Pull up on the console trim bezel and remove. Using an angled screwdriver, remove (2) screws securing the gear shifter bracket to the bezel. Remove (4) screws from the radio trim bezel, remove the factory head unit assembly and disconnect the wiring.

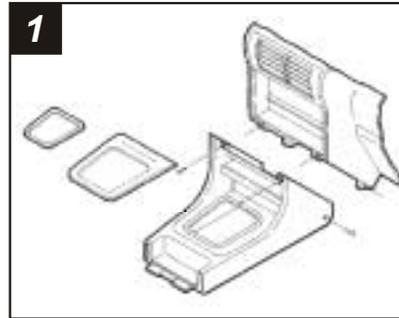
ACURA Integra 1994-01

Disconnect the negative battery terminal to prevent an accidental short circuit. Remove the cover cap located under the emergency brake and remove (2) screws exposed. Remove (2) screws from the rear corners of the lower dash trim bezel and remove. Remove the ashtray and (2) screws exposed. Unsnap the ashtray housing and disconnect the cigarette lighter harness. Remove the gear shifter knob and unsnap the shifter trim. Remove (2) screws below the radio opening and remove the upper dash trim bezel. Remove (2) 8mm screws securing the factory head unit and disconnect the wiring.

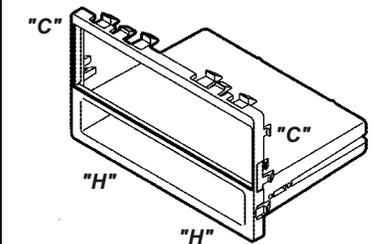
Cut and remove the all mounting clips on the **Radio Housing** EXCEPT clips "C" and "H". (The clips can be identified by the stamped letter near each clip). Skip to step #3b on Page 11.

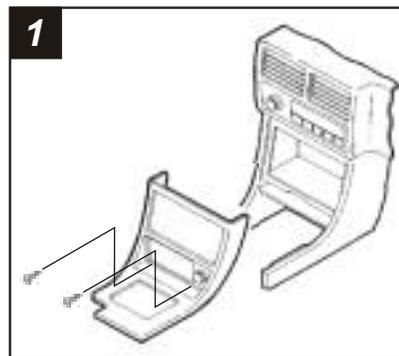
ACURA Legend 1990-96

Disconnect the negative battery terminal to prevent an accidental short circuit. Remove (2) screws below the ashtray. Unclip the dash trim bezel. Disconnect the cigarette lighter wiring and remove the bezel. Remove (2) bolts securing the rear of the factory head unit and disconnect the wiring.

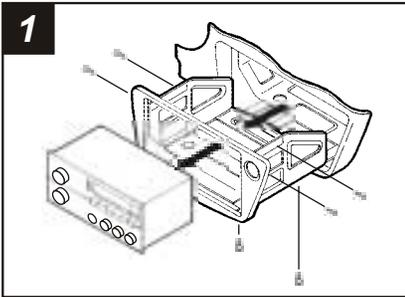
ACURA RSX 2002

1
Disconnect the negative battery terminal to prevent an accidental short circuit. Unclip the lower dash panel (containing the power outlet) and remove the panel. Reach into the opening and remove (2) Phillips screws from the base of the factory head unit. Slide the factory head unit (w/ bracket assembly) from the dash and disconnect the wiring. Remove (4) Phillips screws securing the factory head unit to the bracket assembly and remove the unit. (If a factory pocket is present, remove (4) Phillips screws securing the pocket to the bracket assembly and remove).

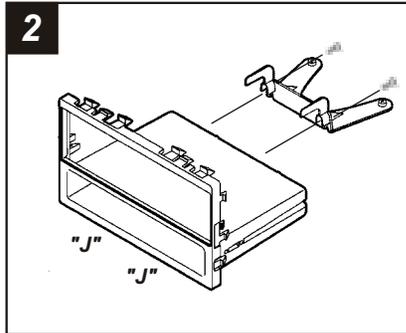
2
Cut and remove the all mounting clips on the **Radio Housing** EXCEPT clips "J". (The clips can be identified by the stamped letter near each clip). Mount the **Rear Support Bracket #R2** to the back of the Radio Housing with (2) #8 x 3/8" Phillips Pan-head Screws supplied. Skip to step #3b on Page 11.

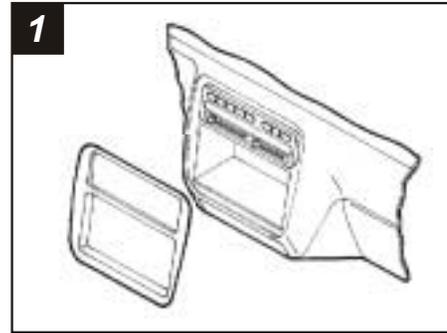
HONDA Odyssey 1995-98 / ISUZU Oasis 1996-99

1
Disconnect the negative battery terminal to prevent an accidental short circuit. Lower the glove box assembly. Remove (2) Phillips screws exposed on the right side of the underdash. Remove (2) Phillips screws from the driver's side knee bolster and (1) Phillips screw in the coin pocket. Remove (5) Phillips screws from the underdash panel and remove the panel. Remove (4) Phillips screws from the cupholder assembly and remove. Remove (2) Phillips screws securing the factory head unit and disconnect the wiring.

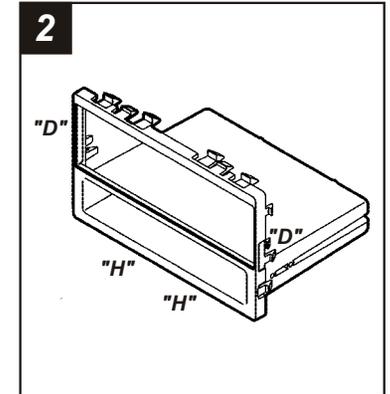
2
Cut and remove the all mounting clips on the **Radio Housing** EXCEPT clips "D" and "H". (The clips can be identified by the stamped letter near each clip). Skip to step #3b on Page 11.

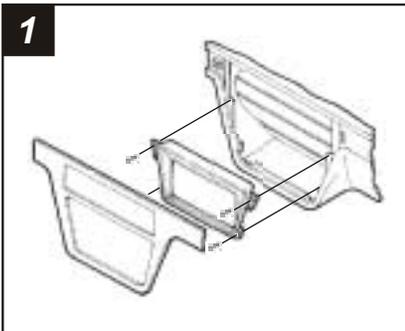
ACURA TL 1996-98

1
Disconnect the negative battery terminal to prevent an accidental short circuit. Using a small screwdriver, unclip the perimeter of the radio trim bezel. Disconnect the climate control and rear defroster wiring and remove the bezel. Remove (4) Phillips screws securing the factory head unit/trim bezel assembly. Loosen (2) Phillips screws securing the back of the head unit to the metal housing and slide the unit out. (It is NOT necessary to remove the screws securing the metal housing to the bezel). Disconnect the wiring.

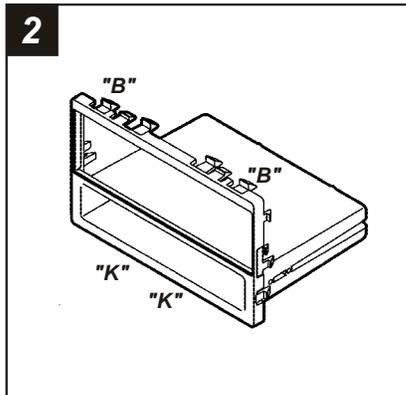
2
Cut and remove the all mounting clips on the **Radio Housing** EXCEPT clips "B" and "K". (The clips can be identified by the stamped letter near each clip). Skip to step #3b on Page 11.

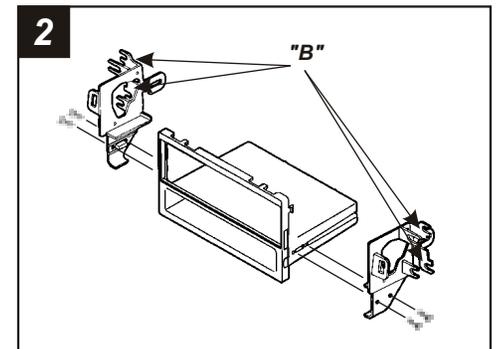
2
Cut and remove the mounting clips from the **Radio Housing**. Locate tabs "B" on the **Mounting Brackets** for mounting, cut and remove tabs "A". (The tabs can be identified by the stamped letter near each tab). Secure the Brackets to the Housing with (4) #8 x 3/8" Phillips Pan-head Screws. Skip to step #3b on Page 11.

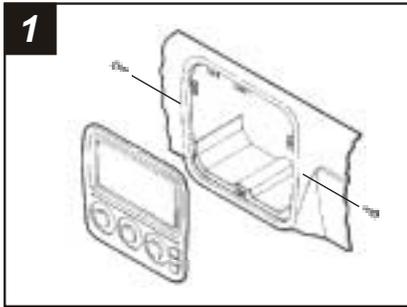
HONDA CR-V 1997-01

1
Disconnect the negative battery terminal to prevent an accidental short circuit. Open the glove box, squeeze the retaining clips and remove the stoppers. Lower the glove box and remove (2) Phillips screws from the left edge. Remove (2) Phillips screws from the lower steering column panel and remove. Unclip the lower console cover (below the ashtray and pocket) and remove. Remove (2) Phillips screws from the base of the center console, open the console pocket and remove the (4) outer screws exposed. Unclip the center console and remove. Remove (2) Phillips screws securing the radio trim bezel, disconnect the wiring, and remove the trim bezel/head unit assembly. Remove (4) Phillips screws securing the head unit to the bezel and remove.

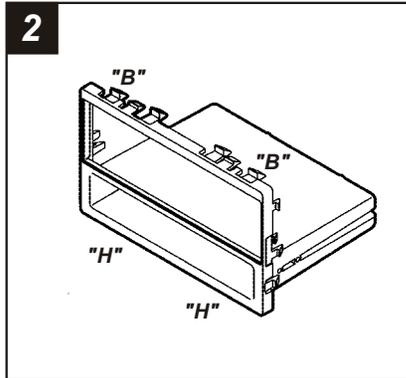
2
Cut and remove the all mounting clips on the **Radio Housing** EXCEPT clips "B" and "H". (The clips can be identified by the stamped letter near each clip). *Skip to step #3b on Page 11.*

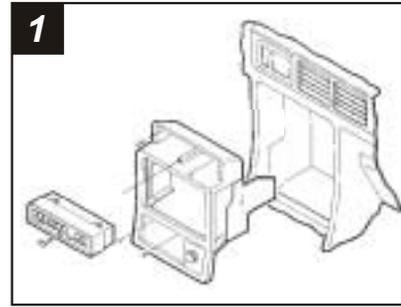
ACURA Vigor 1991-96

1
Disconnect the negative battery terminal to prevent an accidental short circuit. Remove the access cap from the climate control cluster and (1) screw exposed. Unclip the cluster and remove (2) screws exposed. Remove the ashtray and (2) Phillips screws exposed. Remove the cover caps from each front corner of the center console and the screws exposed. Open the storage compartment, lift up the carpet and remove (2) screws exposed. Lift up on the center console and remove. Unclip the radio trim bezel and disconnect the wiring. Remove (2) bolts from the back of the factory head unit and disconnect the wiring.

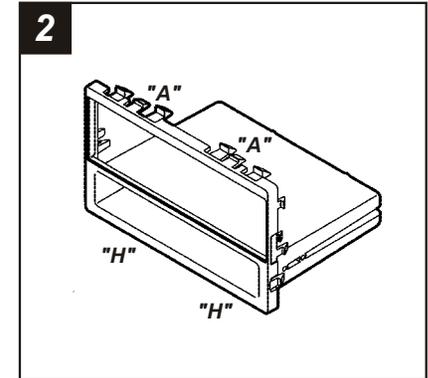
2
Cut and remove the all mounting clips on the **Radio Housing** EXCEPT clips "A" and "H". (The clips can be identified by the stamped letter near each clip). *Skip to step #3b on Page 11.*

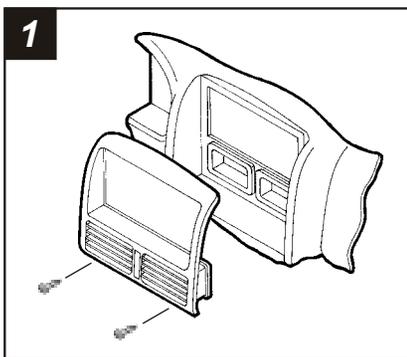
HONDA CR-V 2002

1
Disconnect the negative battery terminal to prevent an accidental short circuit. Remove (2) Phillips screws from the bottom edge of the radio trim bezel. Unclip the trim bezel and remove. Remove (4) Phillips screws securing the factory head unit and disconnect the wiring.

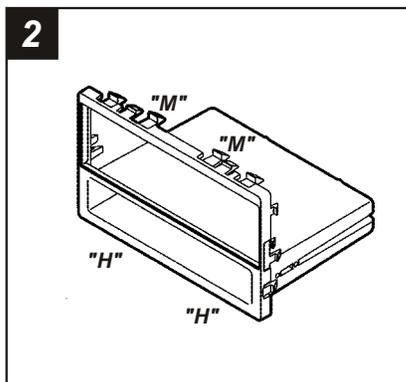
2
Cut and remove the all mounting clips on the **Radio Housing** EXCEPT clips "M" and "H". (The clips can be identified by the stamped letter near each clip). *Skip to step #3b on Page 11.*

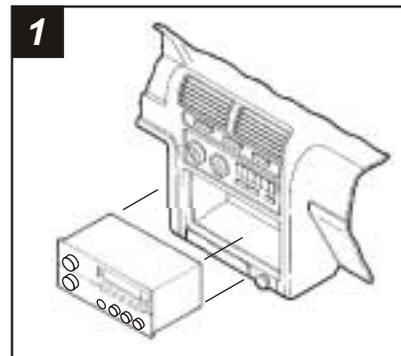
HONDA Accord 1990-93

1
Disconnect the negative battery terminal to prevent an accidental short circuit. Remove (4) screws from the lower portion of the center console. Remove the gear shifter knob and lift the console out. Remove the ashtray and ashtray bracket. Remove (2) screws from the bottom of the head unit support, slide the unit out and disconnect the wiring.

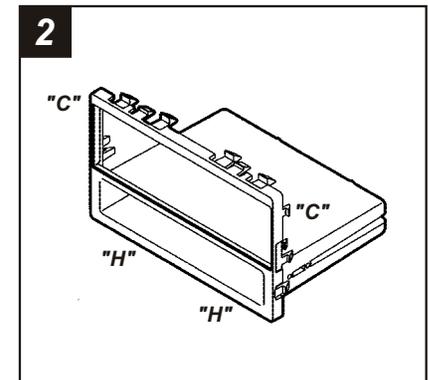
2
Cut and remove the all mounting clips on the **Radio Housing** EXCEPT clips "C" and "H". (The clips can be identified by the stamped letter near each clip). *Skip to step #3b on Page 11.*

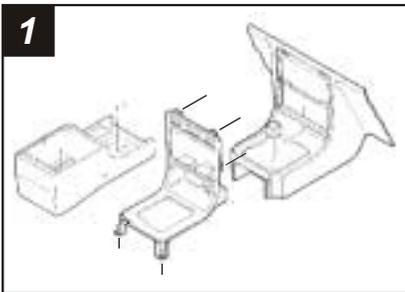
HONDA Accord 1994-97

Disconnect the negative battery terminal to prevent an accidental short circuit. Remove the ashtray and (1) ¼" #8 Phillips screw exposed. Open the storage compartment and remove (2) #8 Phillips screws exposed. Remove the cupholder tray and (3) #8 Phillips screws inside. Lift the center console out and remove (2) Phillips screws exposed at the base of the dash trim bezel. Unclip the bezel and remove. Remove (2) hex-head screws securing the factory head unit and disconnect the wiring.

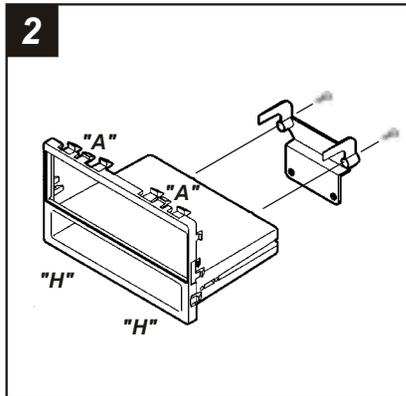
Cut and remove the all mounting clips on the **Radio Housing** EXCEPT clips "A" and "H". (The clips can be identified by the stamped letter near each clip). Mount the **Rear Support Bracket #R1** to the back of the Radio Housing with (2) #8 x 3/8" Phillips Pan-head Screws supplied. Skip to step #3b on Page 11.

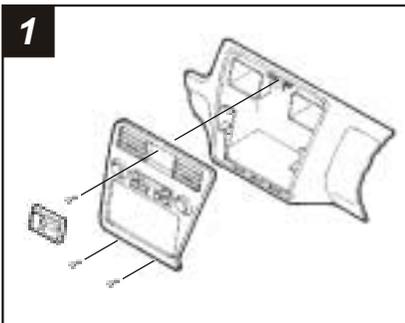
HONDA Accord 1998-02

Disconnect the negative battery terminal to prevent an accidental short circuit. Unsnap the clock panel, disconnect the wiring and remove. Remove (1) Phillips screw exposed in the clock cavity. Remove (2) Phillips screws below the factory head unit. Unclip the radio trim bezel and disconnect the wiring. Remove (4) Phillips screws securing the factory head unit assembly and disconnect the wiring. Remove (2) screws securing the factory pocket to the assembly.

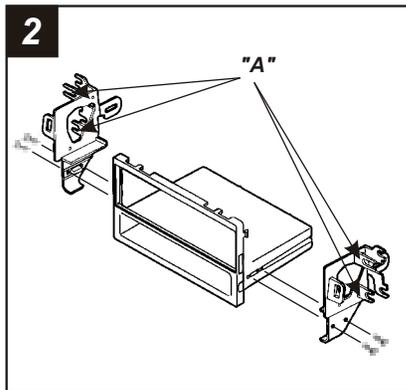
Cut and remove the mounting clips from the **Radio Housing**. Locate tabs "A" on the **Mounting Brackets** for mounting, cut and remove tabs "B". (The tabs can be identified by the stamped letter near each tab). Secure the Brackets to the Housing with (4) #8 x 3/8" Phillips Pan-head Screws. Skip to step #3b on Page 11.

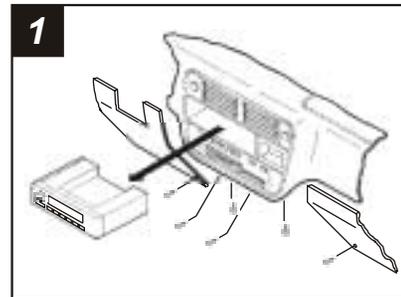
HONDA Civic 1996-98

Disconnect the negative battery terminal to prevent an accidental short circuit. Remove (2) Phillips screws from the bottom edge of the glove box door and remove the door. Remove (3) Phillips screws from the lower steering column panel. Pull straight down on the lower steering column panel and remove the panel. Remove (2) Phillips screws under the climate control panel. Remove (4) Phillips screws from the lower dash location. Remove (2) 8mm hex-head screws securing the bottom-rear of the factory head unit and disconnect the wiring.

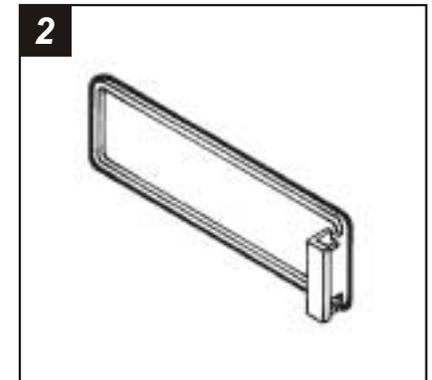
Locate the **Faceplate**. Skip to step #3a on Page 10.

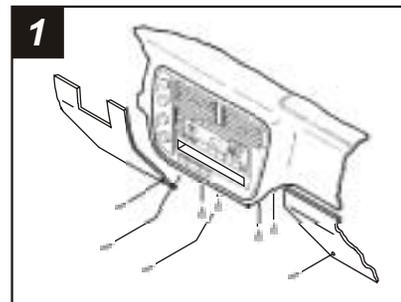
HONDA Civic 1999-00

Disconnect the negative battery terminal to prevent an accidental short circuit. Remove (2) Phillips screws from the bottom edge of the glove box door and remove the door. Remove (3) Phillips screws from the lower steering column panel. Pull straight down on the lower steering column panel and remove the panel. Remove (2) Phillips screws under the climate controls. Remove (4) Phillips screws from the lower dash location. Remove (4) Phillips screws securing the bottom of the dash trim bezel/head unit assembly and pull the assembly out as far as possible. Cut the zip ties securing the head unit and climate control wires, slide the dash trim bezel/head unit assembly from the dash cavity and disconnect the wiring.

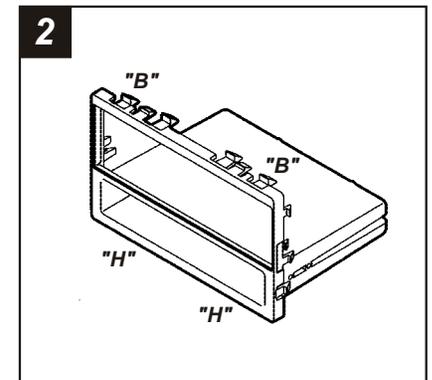
Cut and remove the all mounting clips on the **Radio Housing** EXCEPT clips "B" and "H". (The clips can be identified by the stamped letter near each clip). Skip to step #3b on Page 11.
